2020 *Virtual* PROFESSIONAL ENGINEERS CONFERENCE

From Design to Disaster: Analysis of the Florida International University Pedestrian Bridge Collapse

Miami, Florida. March 15, 2018

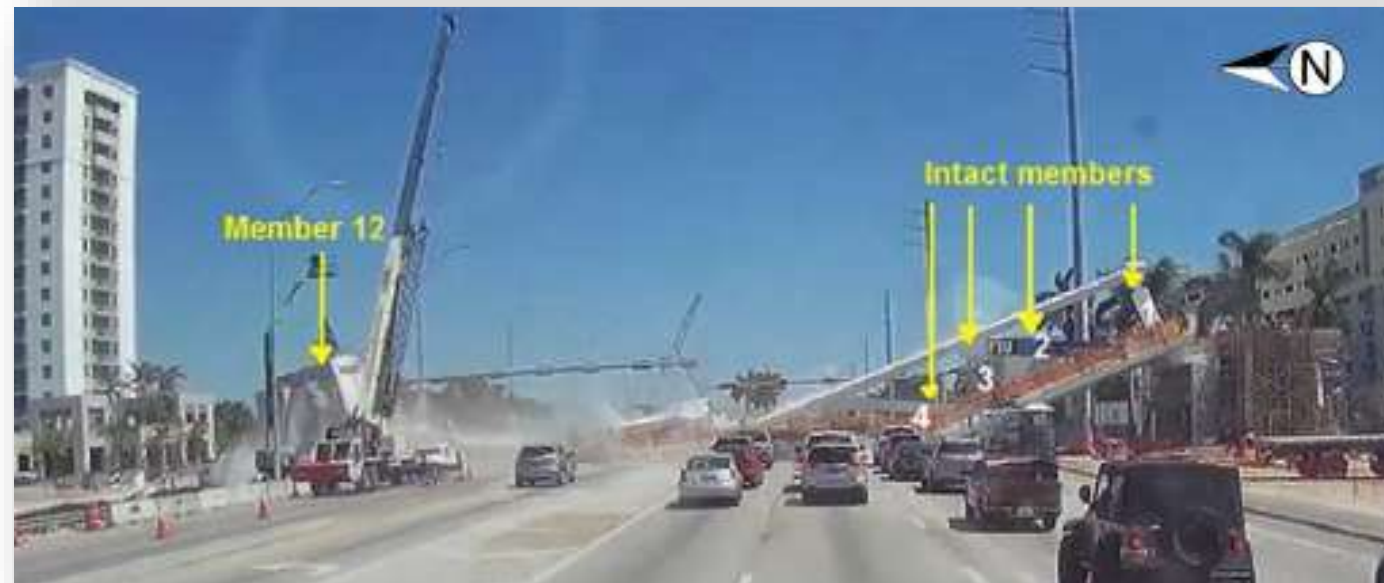
**Concrete
blowout**

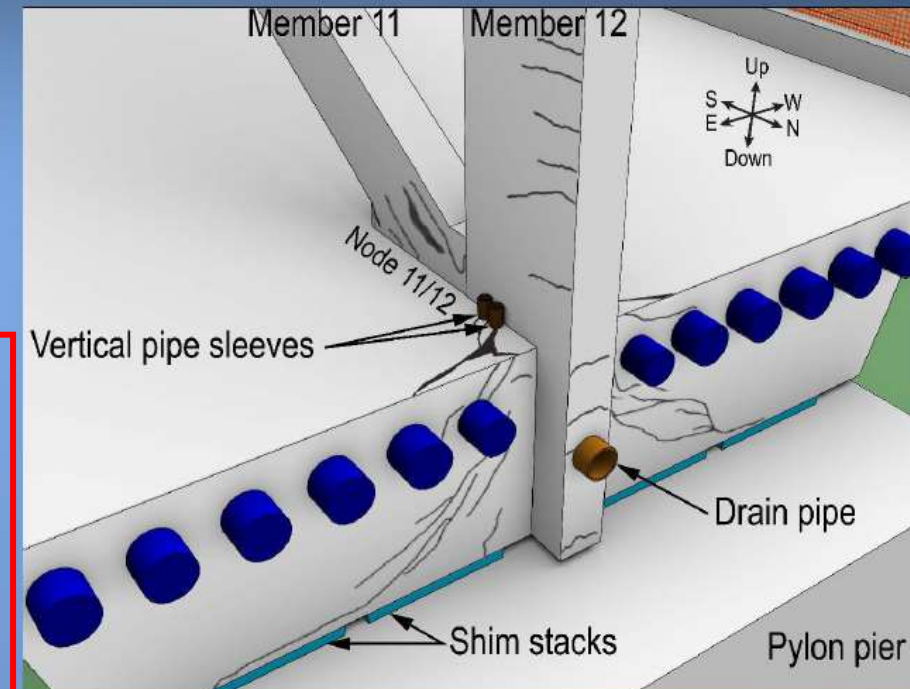
Cracking in Member 11/12 Nodal Region

- Structure showed notable cracking of reinforced concrete
- Extensive and large cracks in member 11/12 should have been recognized as abnormal
 - Cracks up to 0.016 inch wide – considered acceptable
 - Structural cracks in bridge were up to 0.75 inch wide – 40 times larger than typically acceptable
- Scale of cracking clear indication that load-resisting mechanisms were failing

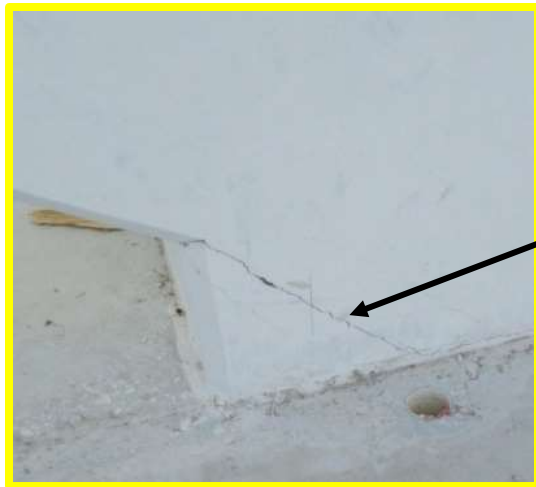
First Signs of Structural Distress

- Portion of crack bypassed 25% of reinforcing steel at base of member 11

Crack passed above the southernmost two size 7 rebars

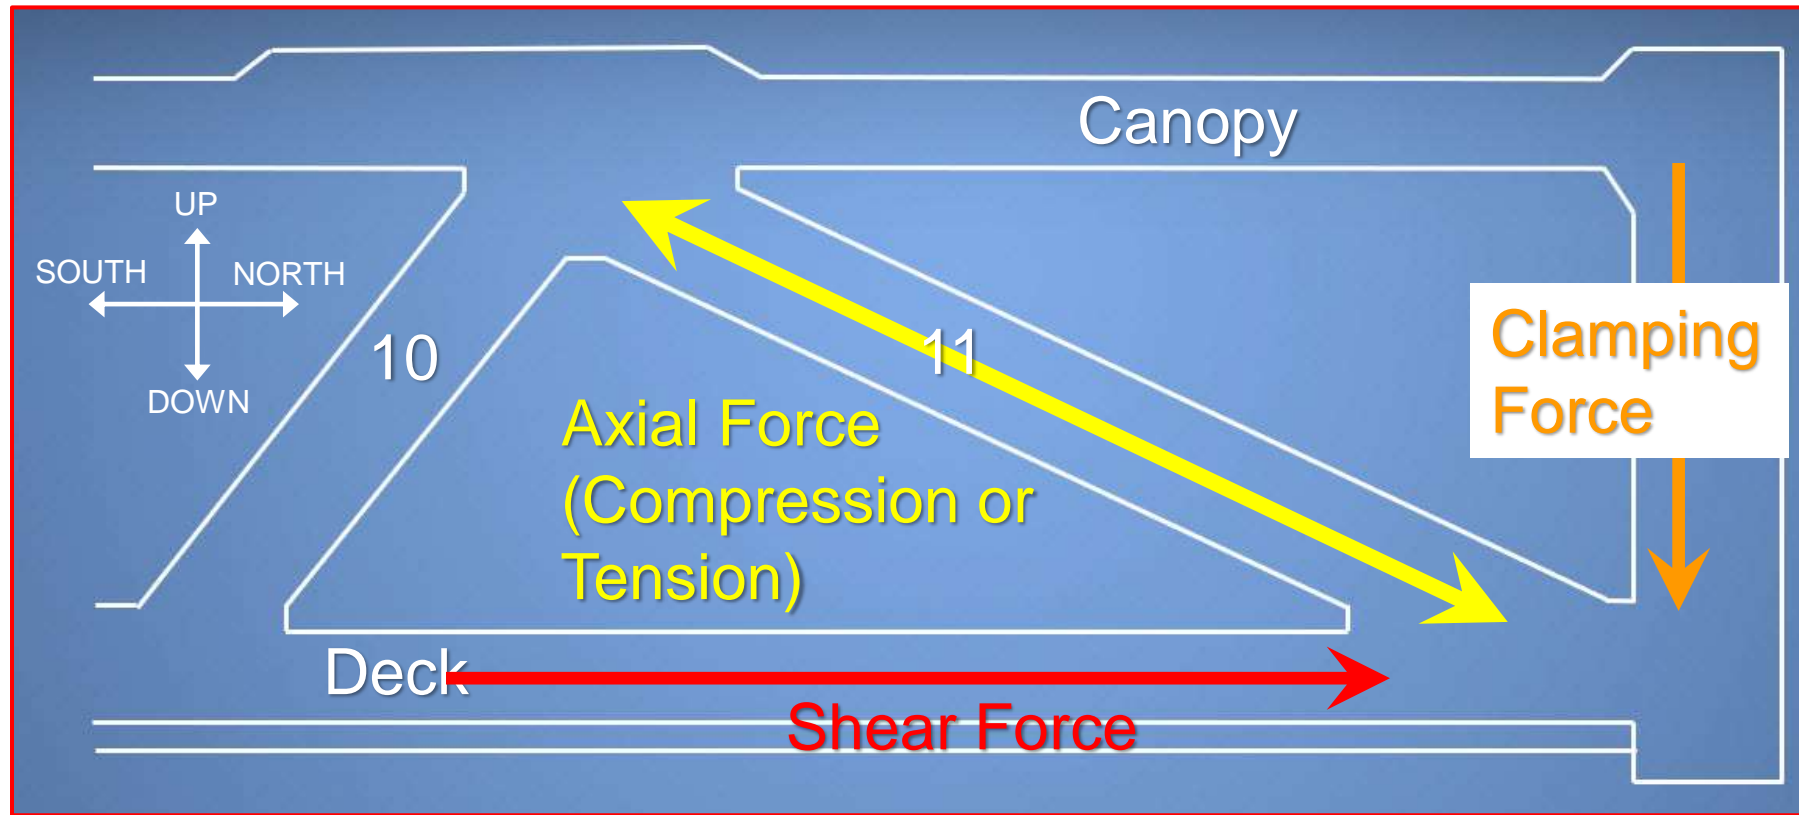
Forces on 11/12 nodal region

Magnitude of horizontal
force –
60 percent larger than
vertical force

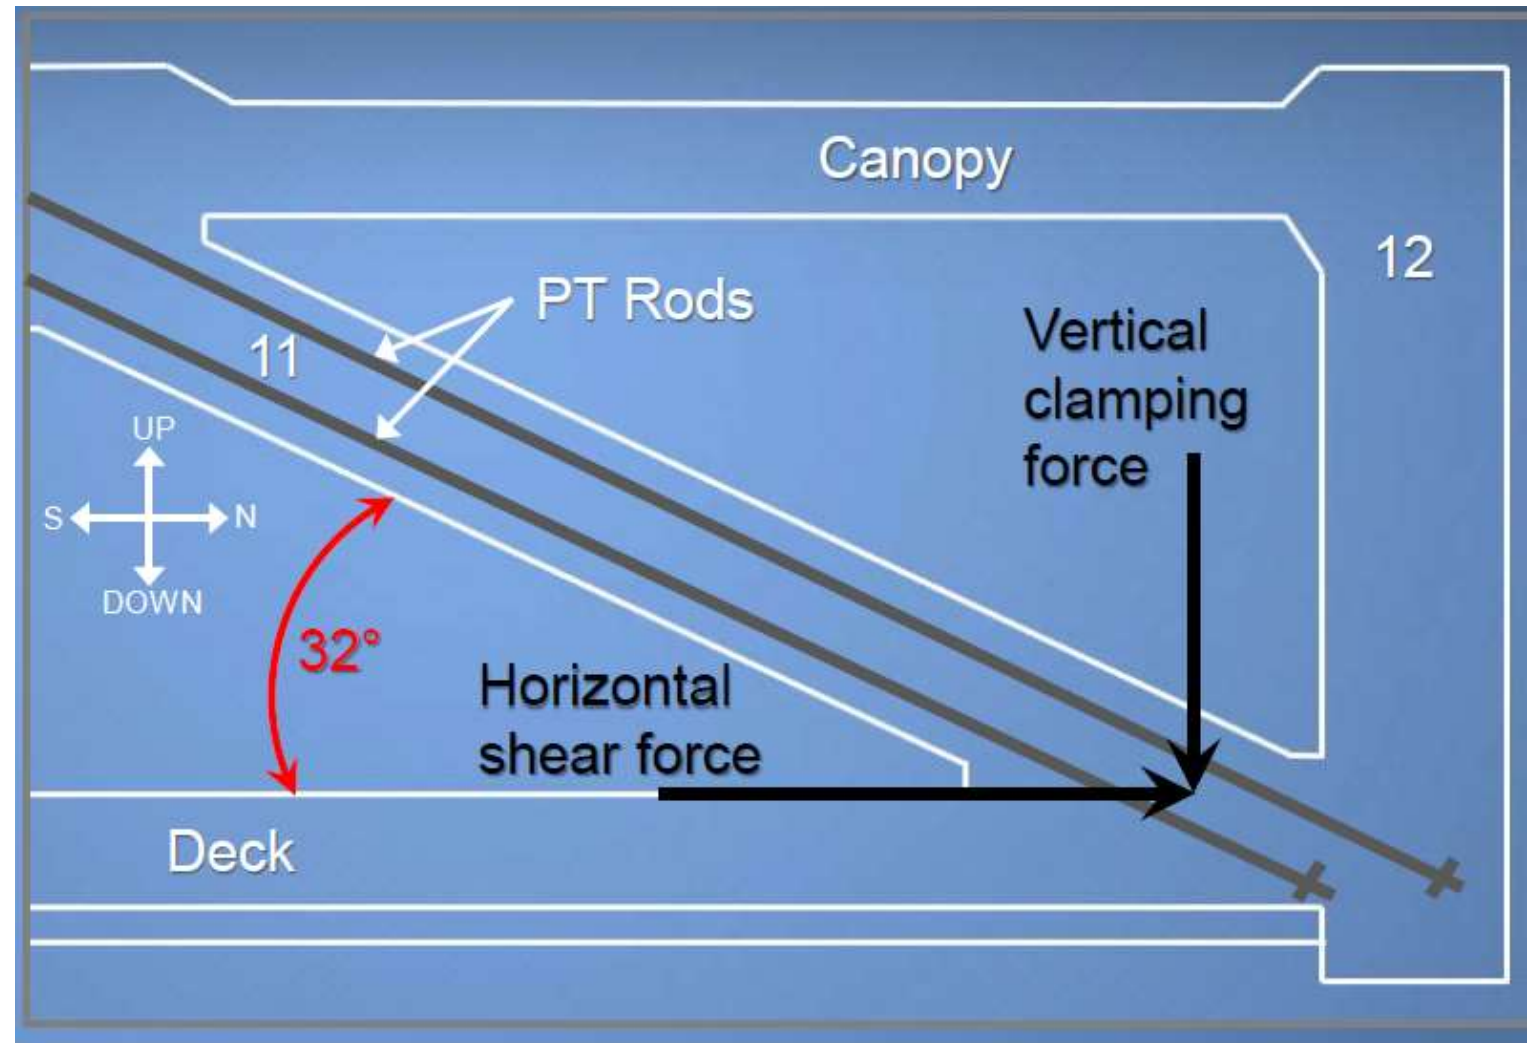
Interface Shear Demand

Figg underestimated interface shear demand at nodal region 11/12 by 46%.

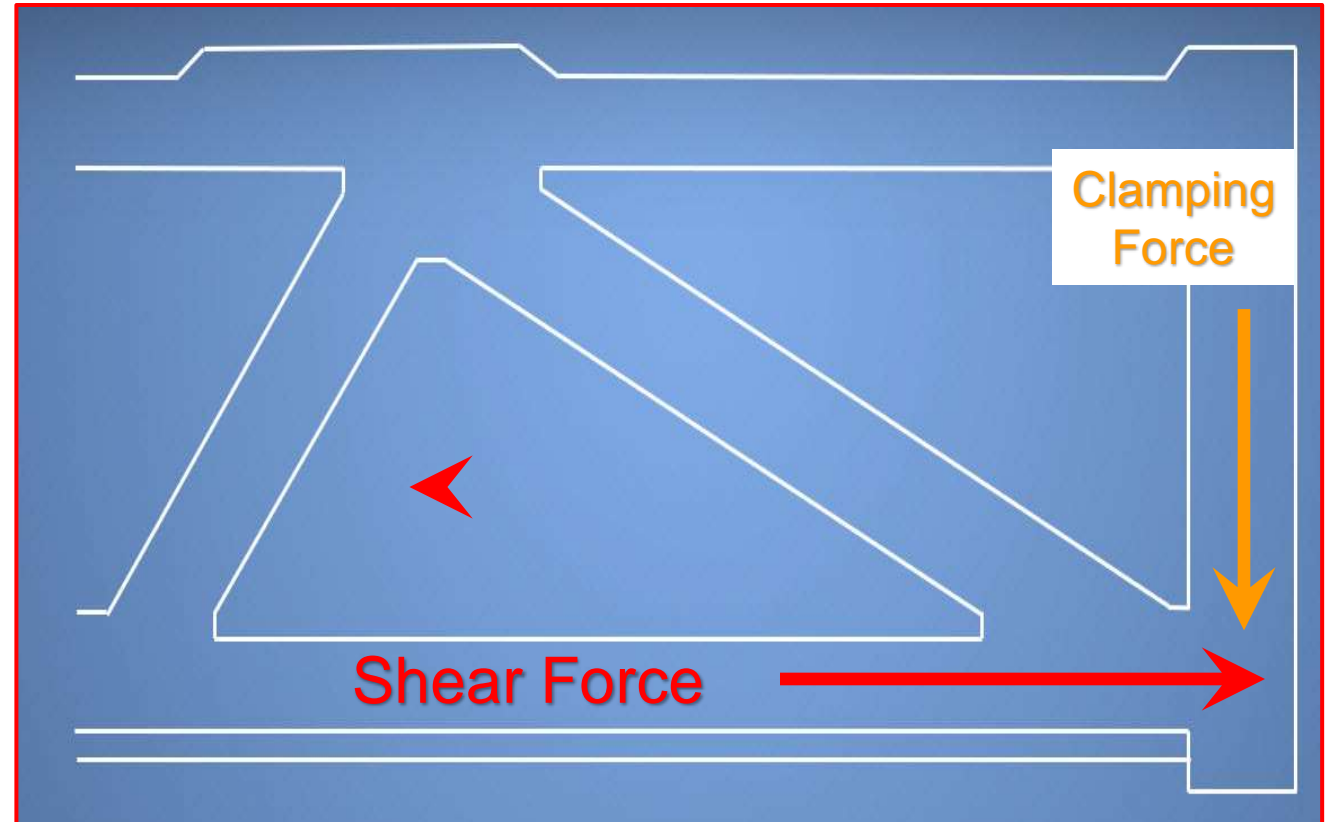
270 percent more rebar needed

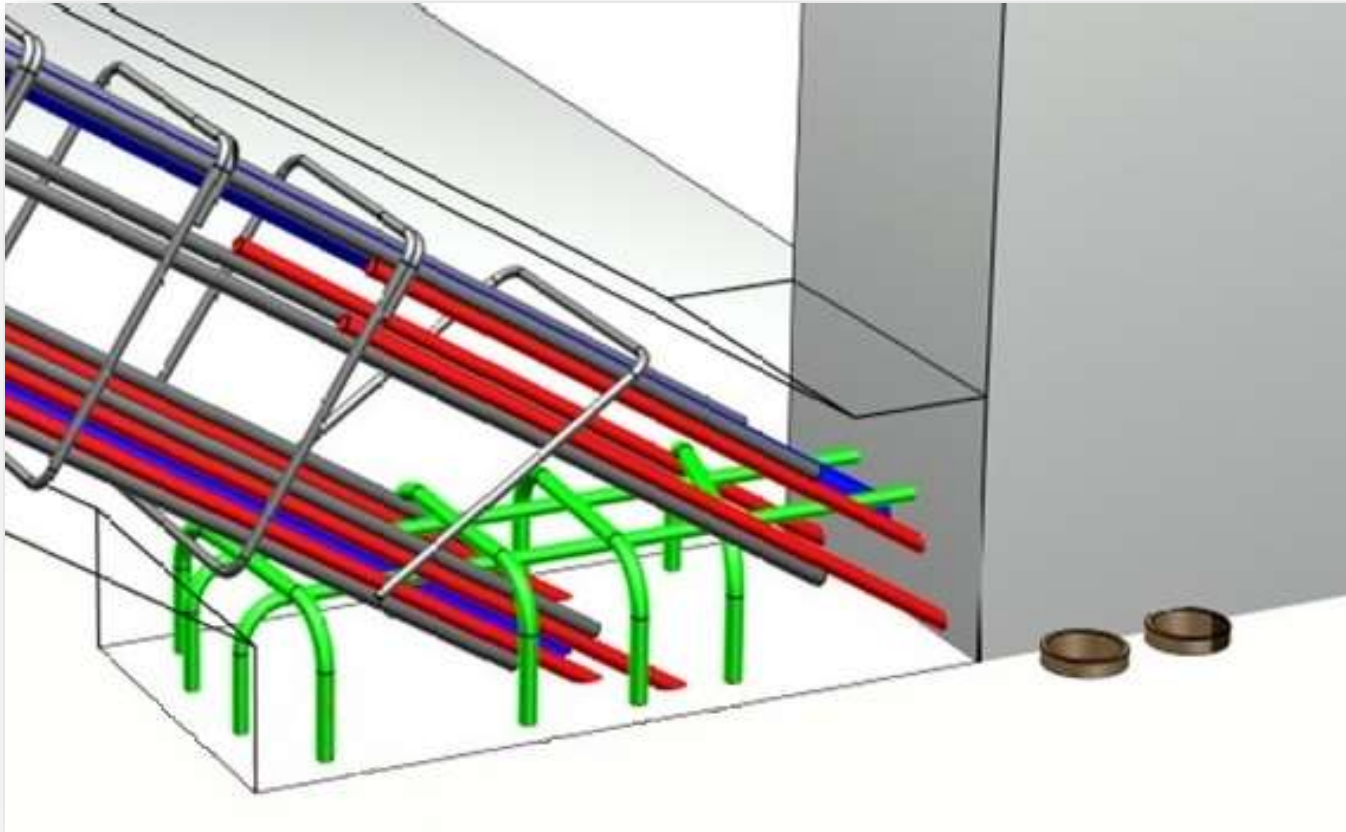
- Member 11 needed **18** square inches cross sectional area of rebar.
- It only had 4.8 square inches.
